FLOOD PLAIN MANAGEMENT STUDY

GAP CREEK
CONWAY COUNTY
ARKANSAS

U. S. Department of Agriculture
Soil Conservation Service
Post Office Box 2323
Little Rock, Arkansas 72203

AUGUST 1981

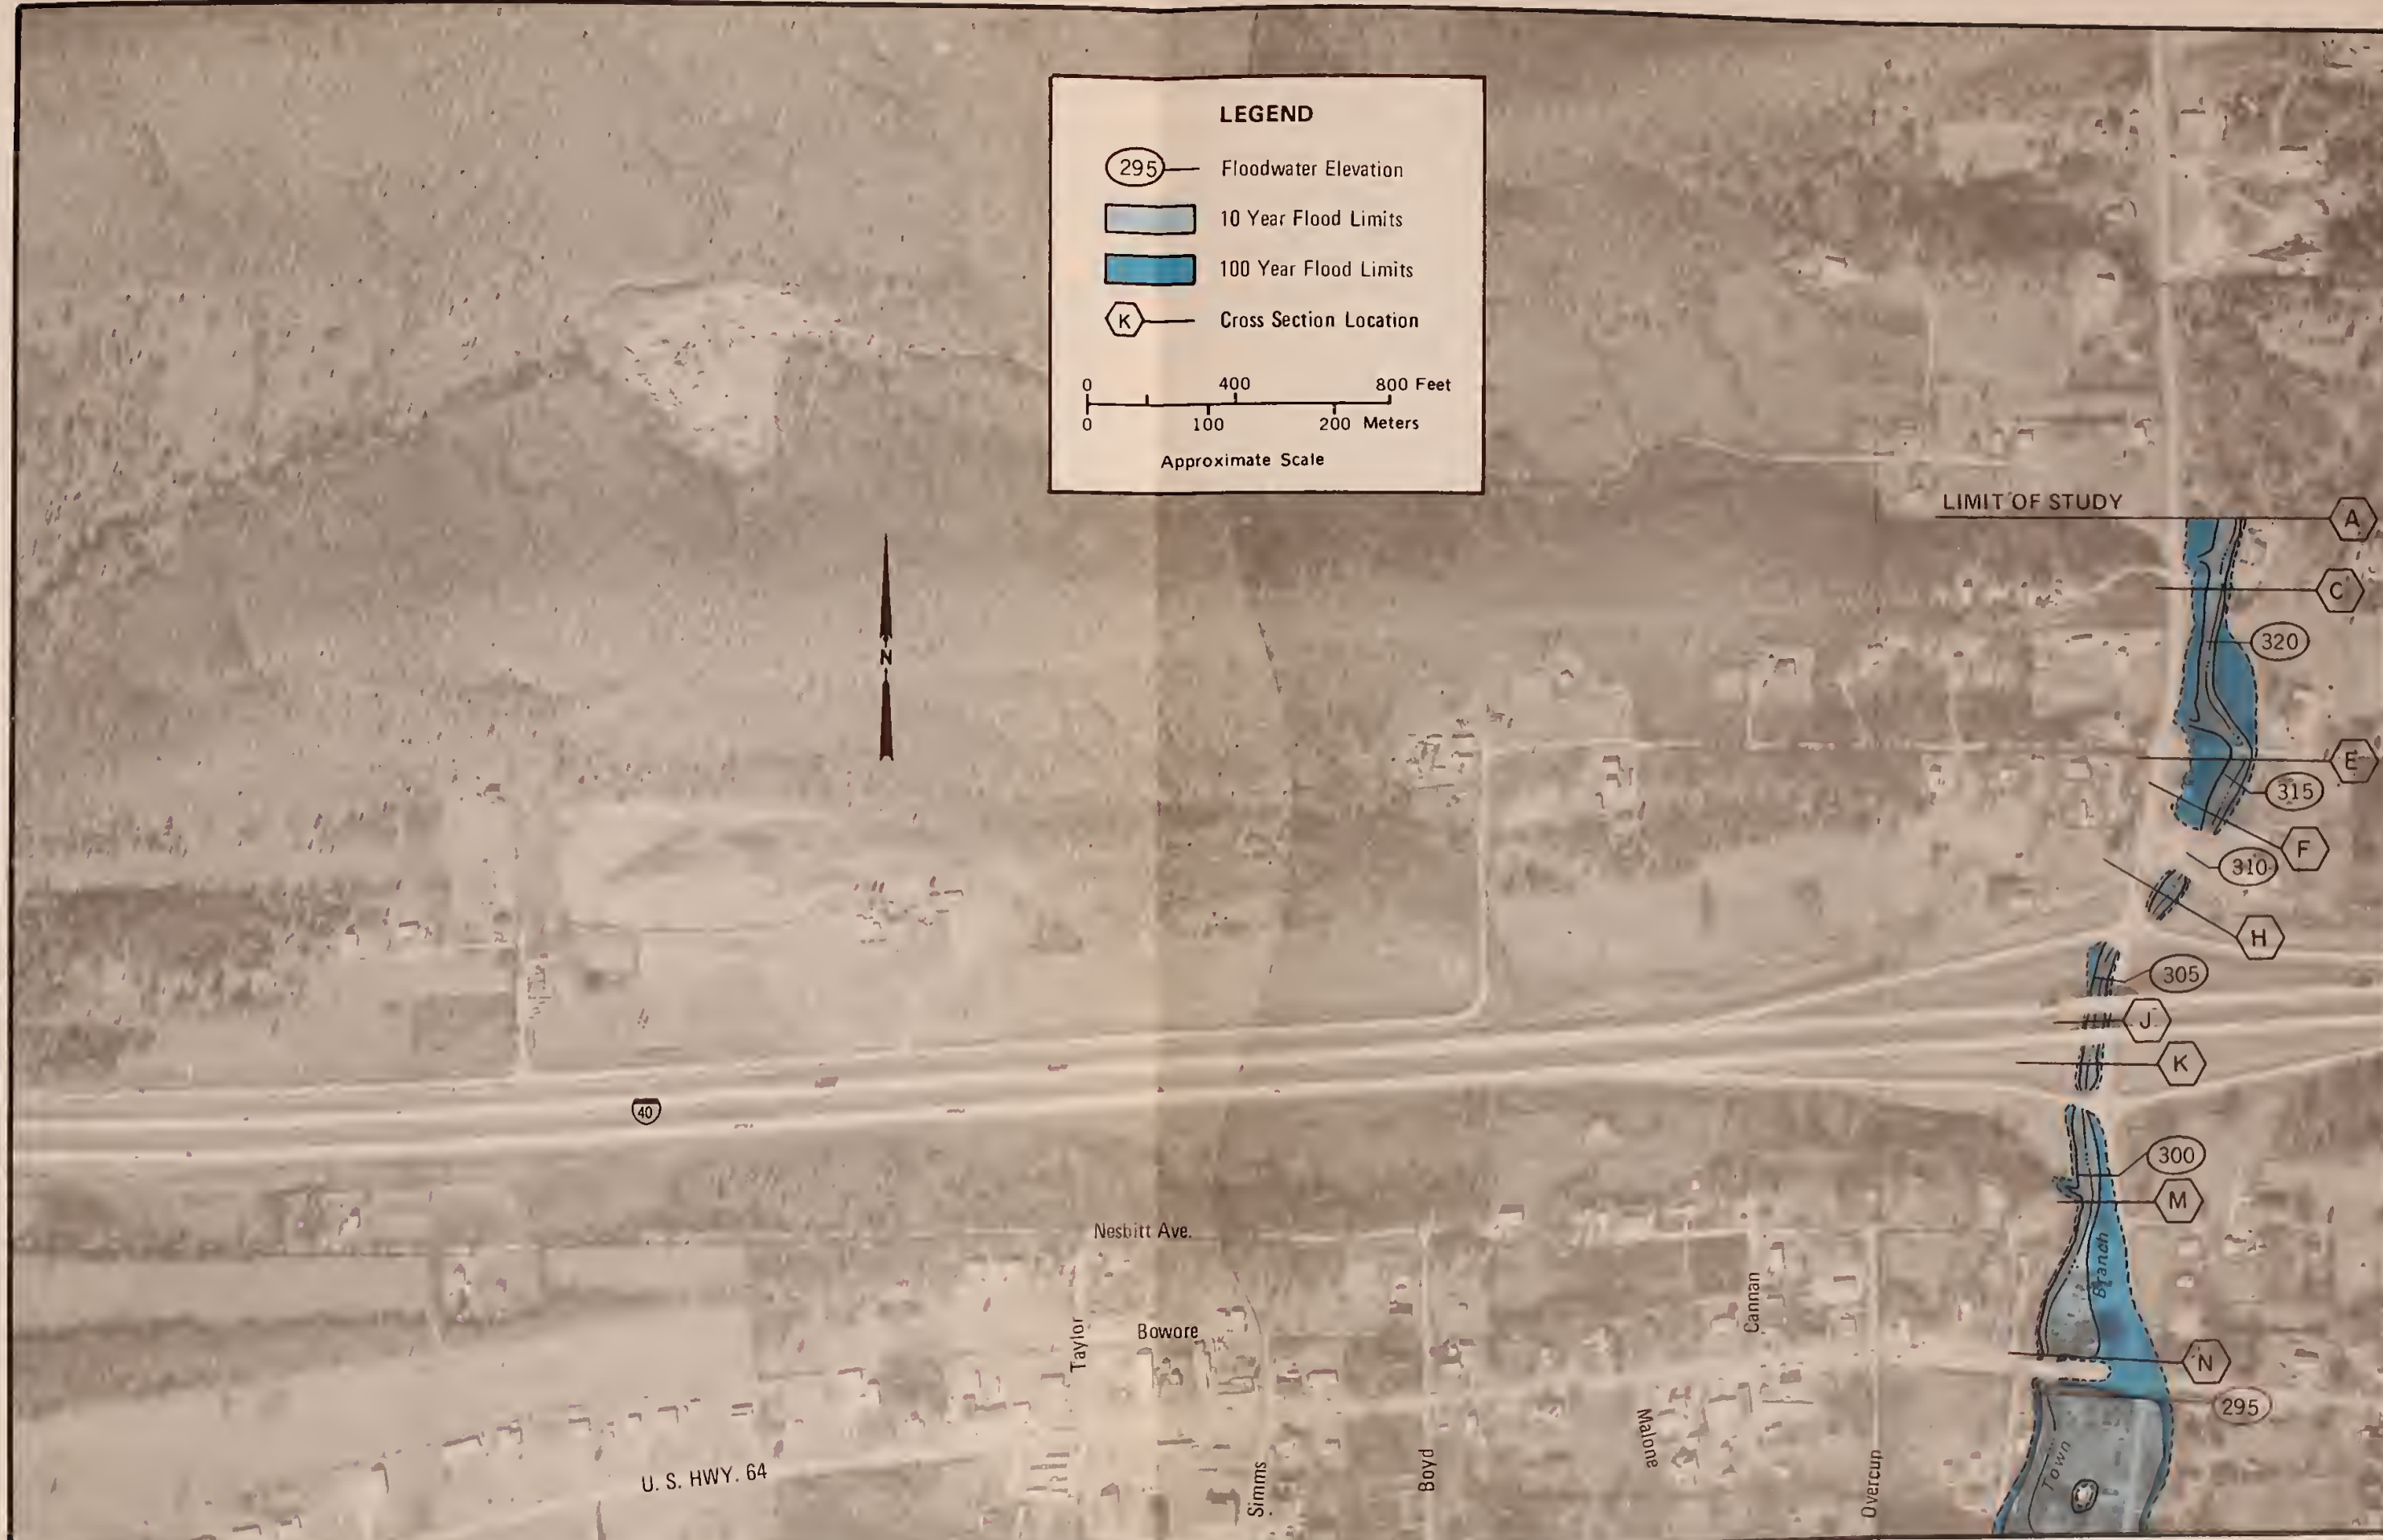
SHEET 1 OF 3

FLOOD PLAIN MANAGEMENT AREA

TOWN BRANCH

- 290 — Floodwater Elevation
- 10 Year Flood Limits
- 100 Year Flood Limits
- N — Cross Section Location

A 100-year frequency flood event would flood 20 acres of urban land (scattered housing) and 42 acres of forestland (see Exhibits 3A, 3B, and 3C) and would damage three single family dwellings and 13 commercial establishments. A 10-year frequency flood event would damage three commercial establishments. Future upland land use changes are not expected to appreciably change the nature of flooding.

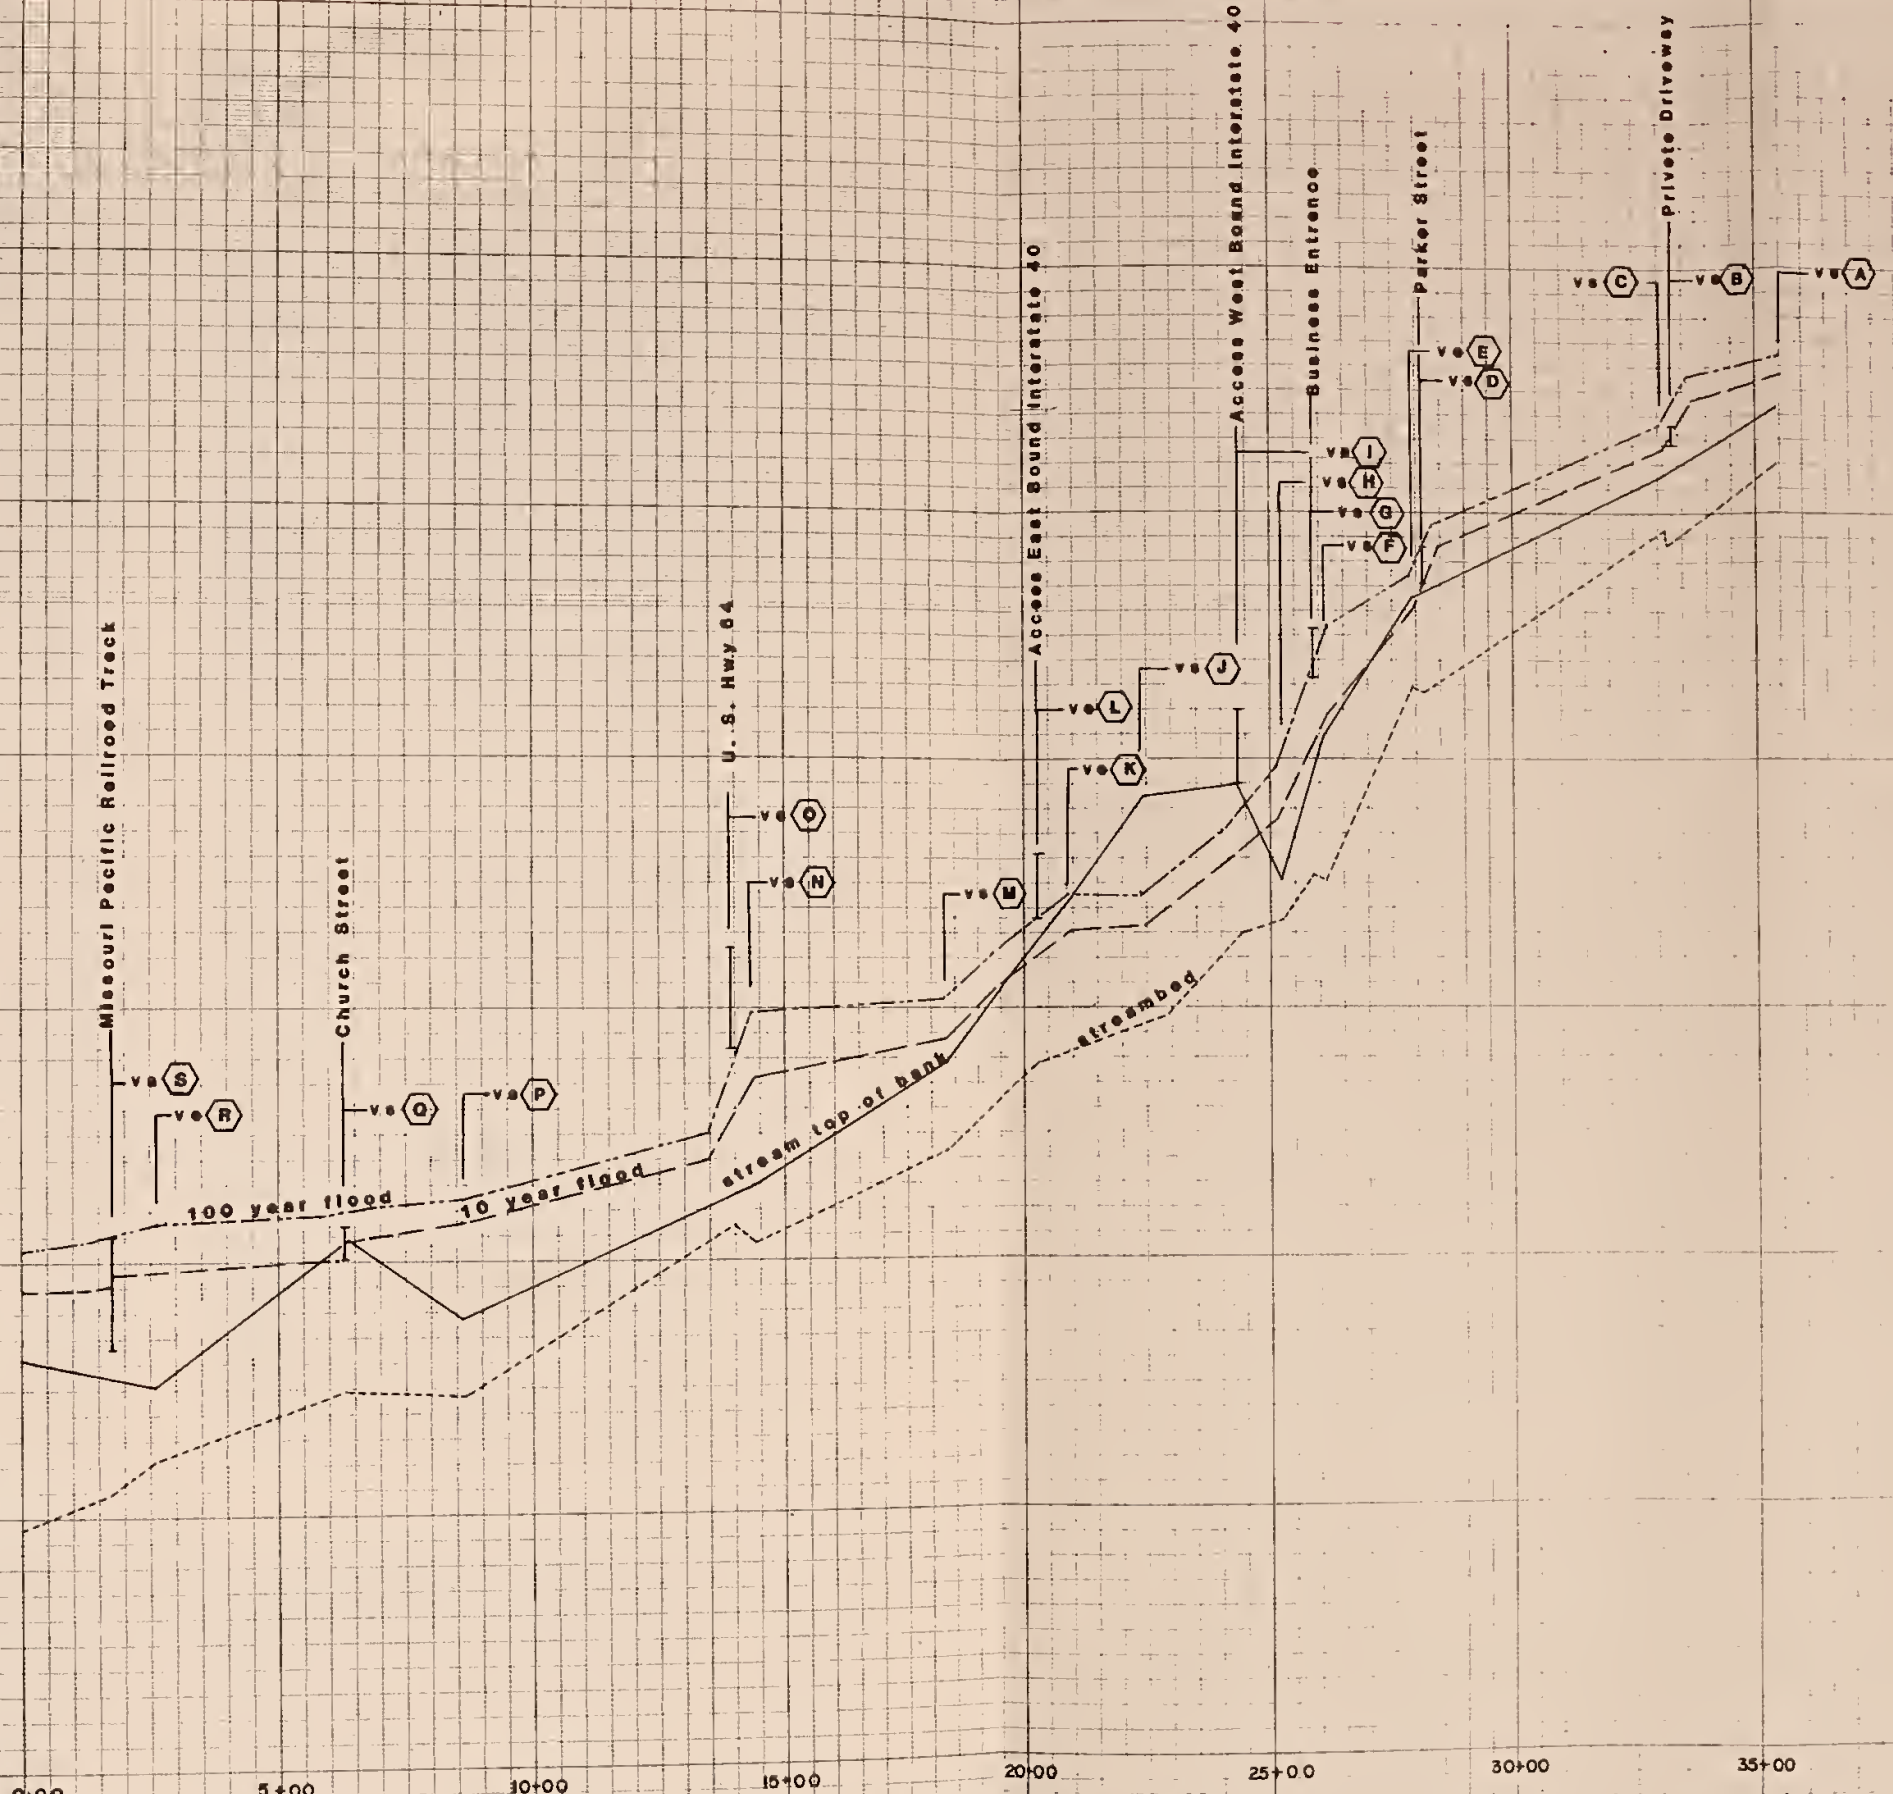
**OAP CREEK
FLOODPLAIN MANAGEMENT STUDY
TOWN BRANCH PROFILES**

A	0.5	382	735	325.7	326.4
B	0.7	497	956	324.6 ^{4/}	325.4 ^{4/}
C	0.7	497	956	322.6	323.6
D	0.7	497	956	318.7 ^{4/}	319.6 ^{4/}
E	0.7	497	956	316.2	317.5
F	0.8	551	1061	311.8	315.4
G	0.8	551	1061	311.5 ^{4/}	315.2 ^{4/}
H	0.8	551	1061	307.6	309.8
I	0.8	551	1061	307.7 ^{4/}	309.8 ^{4/}
J	0.8	551	1061	303.3	304.5
K	0.8	551	1061	303.1	304.6
L	0.8	551	1061	302.4 ^{4/}	304.1 ^{4/}
M	1.0	657	1262	298.8	300.4
N	1.0	657	1262	297.3	299.8
O	1.0	657	1262	297.0 ^{4/}	299.4 ^{4/}
P	1.0	707	1360	291.5	292.4
Q	1.1	707	1360	290.8 ^{4/}	292.1 ^{4/}
R	1.3	806	1549	289.7	291.5
S	1.3	806	1549	289.7 ^{4/}	291.5 ^{4/}
